Manhole Inspection Summary

Manhole # S13QQ1018MH

Location Address: **2708 GARRISON AVE**

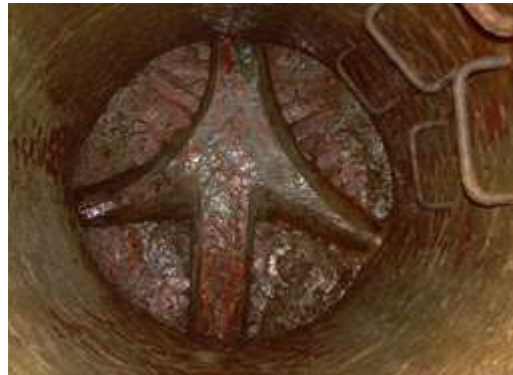
Top View

Corroded steps. Bench debris.

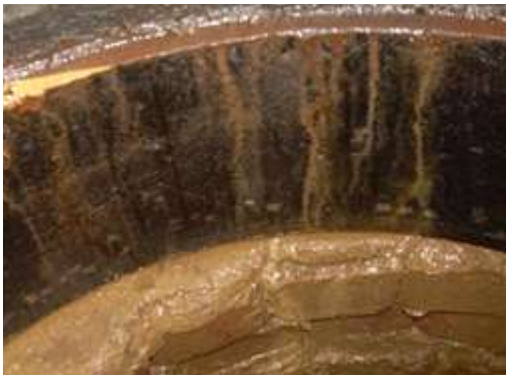
Defect

Frame offset. Corbel infiltration.

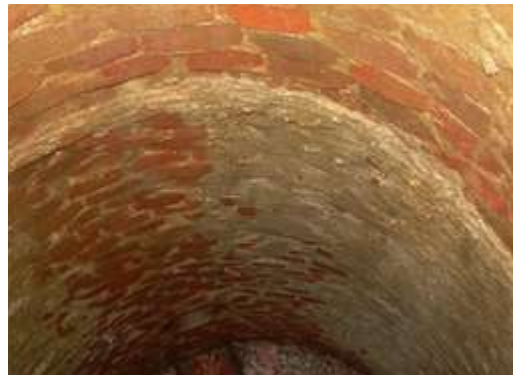
Defect

Barrel infiltration.

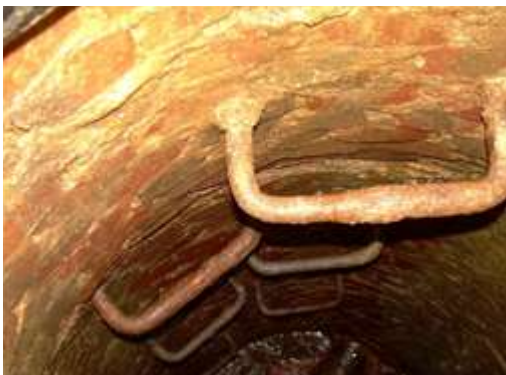
Defect

Corbel and Barrel infiltration.

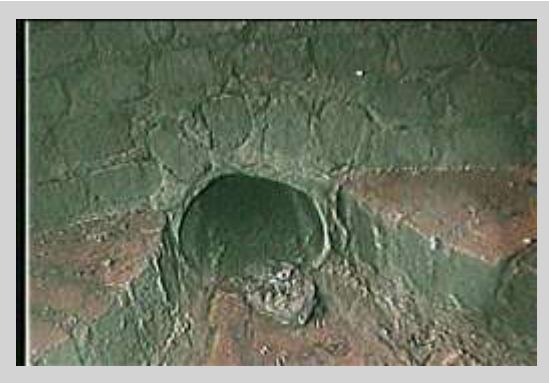
8 in. Circular Gravity Sewer Pipe Out @ 12 O'Clock

Barrel deterioration and infiltration. Channel deterioration.

Deposits: ☐ None ☒ **Mud** ☐ Sludge ☒ **Debris** ☒ **Grease**

Infiltration: **Evidence** Pipe Seal Cond: **Cracked**

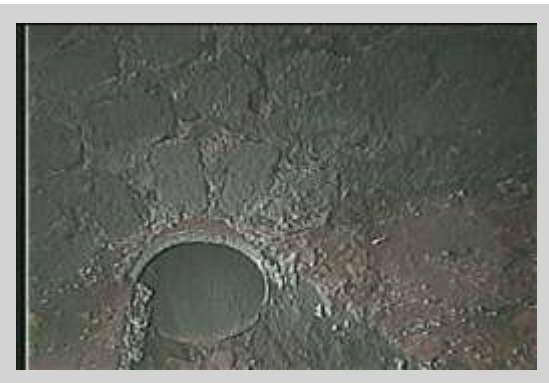
6 in. Circular Gravity Sewer Pipe In @ 3 O'Clock

Infiltration: **Evidence** Pipe Seal Cond: **Cracked**

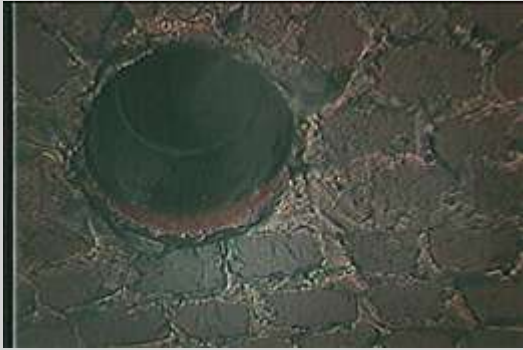
Pipe In @ 6 O'Clock

Barrel deterioration and infiltration. Channel deterioration.

Infiltration: **Evidence** Pipe Seal Cond: **Cracked**

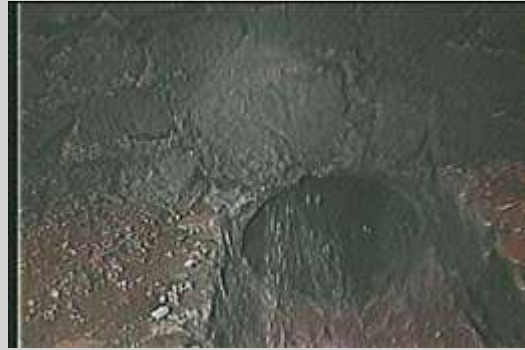
Drop In @ 6 O'Clock

Drop: **Outside** Rod and Bar

Drop Condition: **Open**

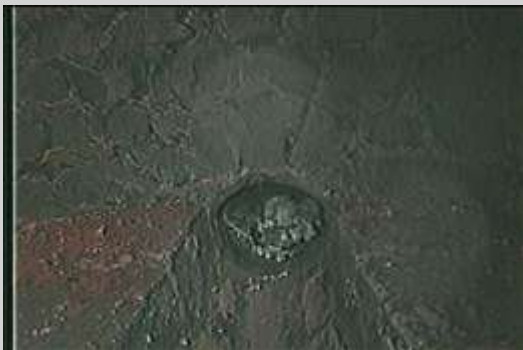
Pipe In @ 9 O'Clock

Deposits: ☐ None ☒ **Mud** ☐ Sludge ☒ **Debris** ☐ Grease

Silt Depth: **3** (in.) Deposits Extent: **Medium**

Infiltration: **Evidence** Pipe Seal Cond: **Cracked**
